Projects Revisited— Bonded Flume Fillets Yuba-Bear River Project

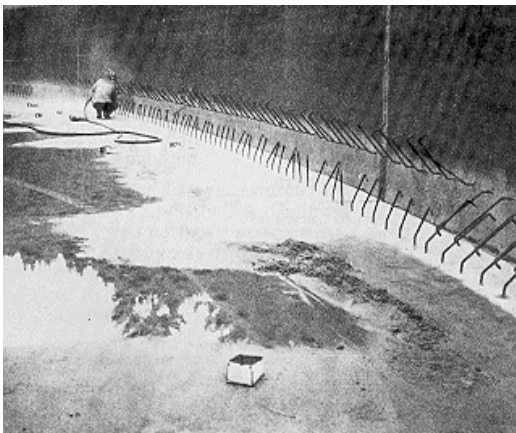
(Left) Reinforcement in the Chicago Park flume consists of 3/4-in. hookbars on 12-in. centers which were epoxy paste grouted.

The successful reinforcement of the Dutch Flat flume prompted the filleting of 5000 lin. ft. of the outside wall of Chicago Park flume in 1968, 2500 lin. ft. in 1970 and 1500 lin. ft. in 1973. The fillet in this larger flume is 20 in. high and 21 in. wide on the invert.

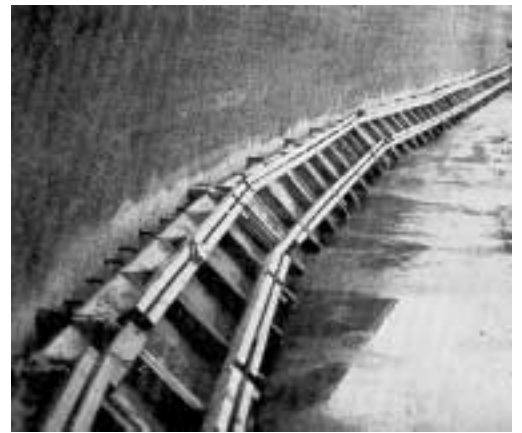
(Right) After sandblasting, wood forms were built. A very long potlife liquid epoxy bonding agent was sprayed onto concrete and steel, and a 6-1/2 sack portland cement concrete poured.

Reinforcement design called for drilling 41/4 in. deep holes into the wall and invert, driving concrete bolt anchors into the invert and hookbars into the wall, pressure testing the anchors to 7000#, sandblasting the concrete and reinforcing steel, erecting wooden forms, spraying a long potlife structural epoxy on concrete and steel surfaces, and placing a 2-1/2 in. maximum slump portland cement concrete with a minimum 2 in. thick concrete cover over the steel.
